MARYLAND HISTORICAL TRUST ABRIDGED INVENTORY FORM
INTERCOUNTY CONNECTOR PROJECT

Property Name: Milton Johnson Property
Survey No.: PACS A8.4 M: 22-47

Property Address 17027 Redland Road, Rockville, Montgomery County Maryland

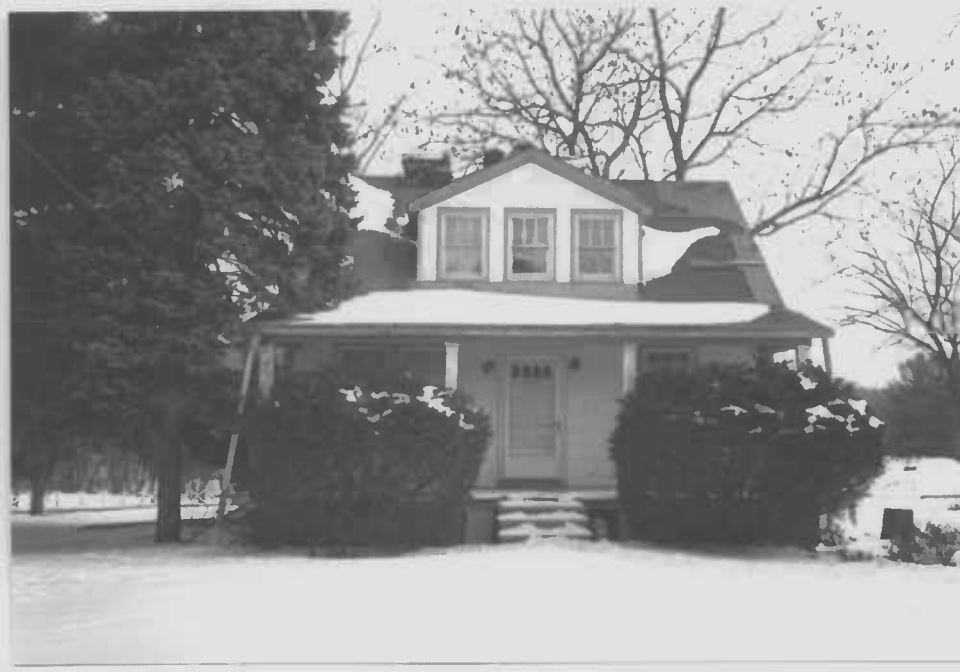
5. 1/4

4. 17021 Redland Road
front (west) elevation

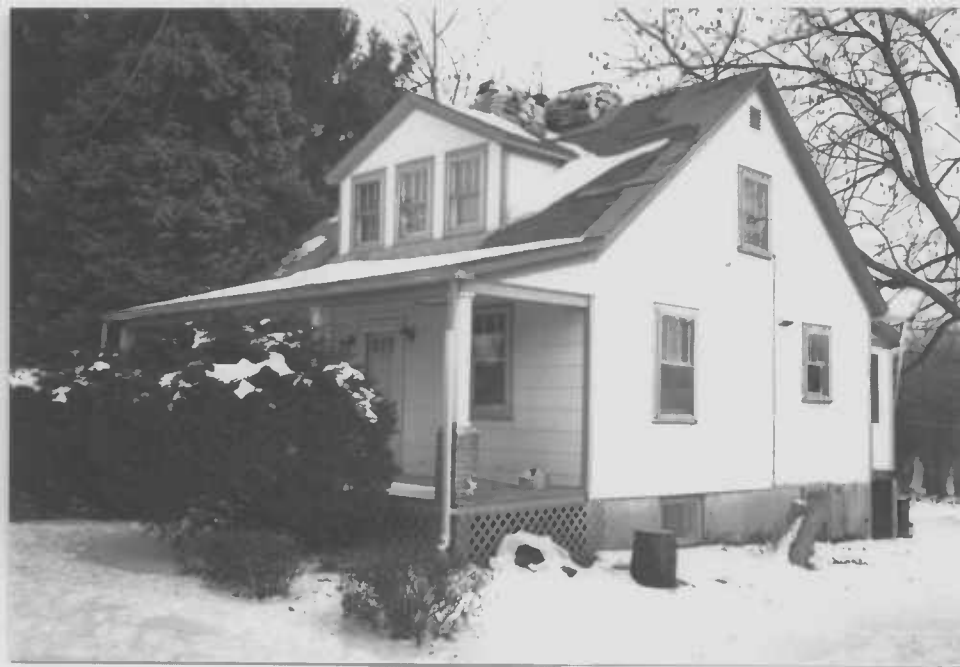
- 1 ~~PACSON~~ M:22-47
- 2 Matten Gelner Property
- 3 Montgomery County
- 4 Tim Tamburino
- 5 February 1996
- 6 PAC Spewand Company, Towson MD
- 7 17027 Redland Road
Southwest corner
- 8 2/4

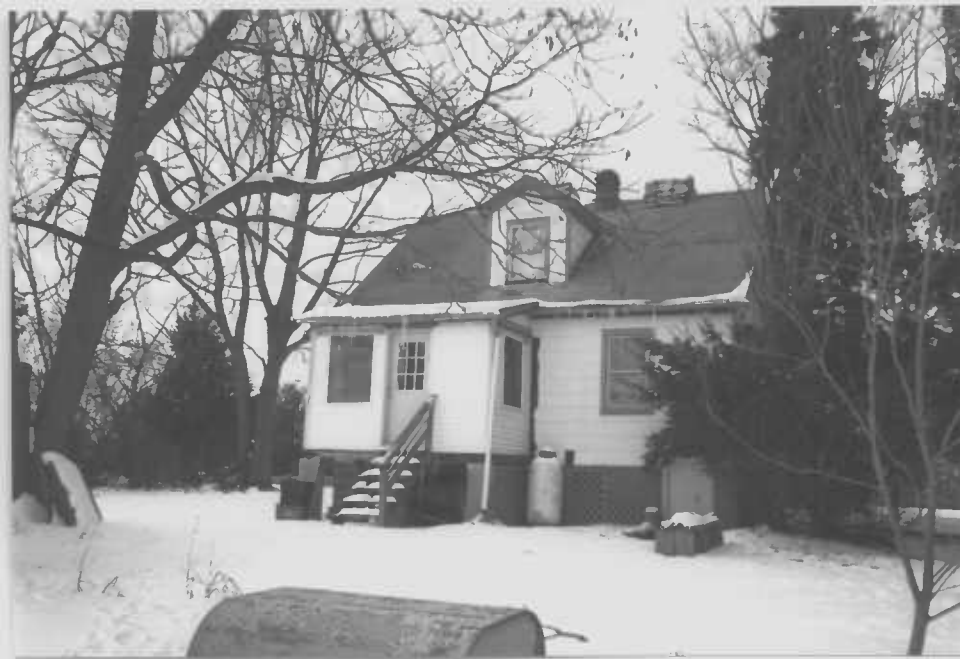
8 $\frac{3}{4}$

7 17027 Redland Road

near, or east elevation

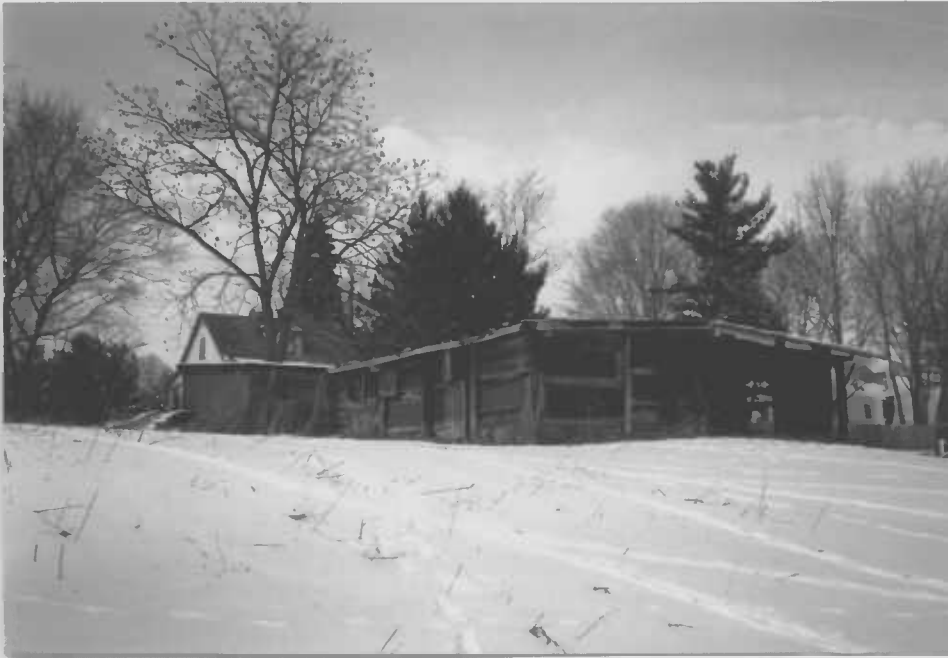
8 ~~4/4~~

There are two outbuildings associated with this property. The first outbuilding is a garage, with a shed roof covered with asphalt shingles. Constructed circa 1930, it is of concrete construction. The structure is located southeast of the house.

The second outbuilding is a stable, with a low-pitched gable roof. Constructed circa 1930 it is of post and beam construction. The structure is located east of the house.

7 ~~17027 Redland Road
out buildings~~
